# Reduction and control of sediment-laden runoff near critical coral reef ecosystems through the implementation of BMP'S in Culebra, Puerto Rico

March, 2016

## RUNOFF AND EROSION CONTROL MEASURES FULLADOZA SITE

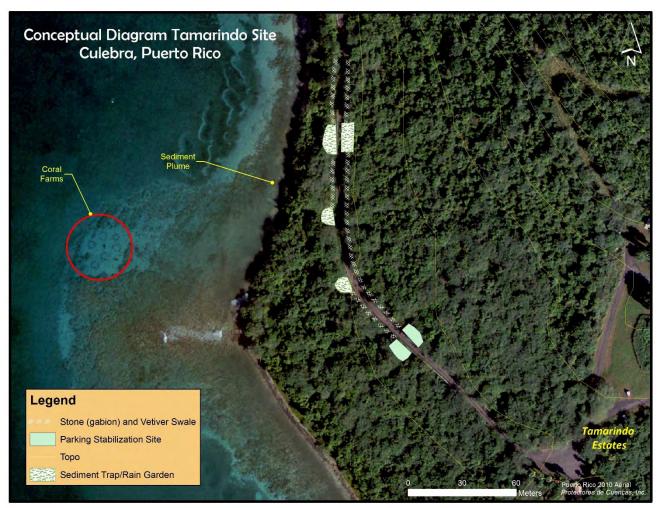
Figure 2. Conceptual diagram of work completed at Tamarindo Beach.

A micro-watershed approach was used as a management unit for this coastal area (Figure 2). The problems identified in Tamarindo were mainly associated with runoff generated from the exposed dirt turnaround (Figure 3) and the extensive areas of unpaved road in areas that drain directly to the Marine Reserve (Figure 4). Existing infrastructure was in a critical state of disrepair with rutting and small undesirable watercourses conveying runoff and sediment down to Tamarindo Beach. This was causing bank erosion that was yielding considerable amounts of sediments directly to coral reef communities (Figures 5).

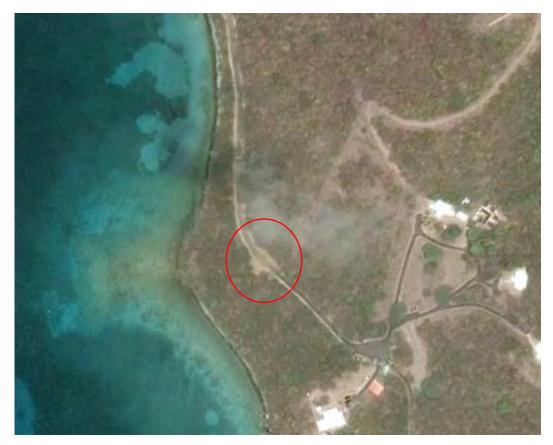
Figure 3. Google Earth August 2015 aerial with turnaround area of Tamarindo in red circle before stabilization.

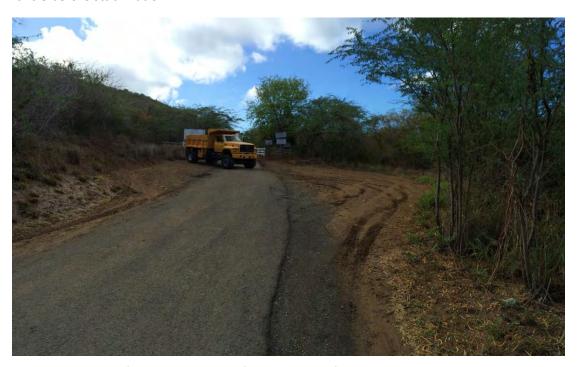
Figure 4. Picture of turnaround area of Tamarindo before stabilization.

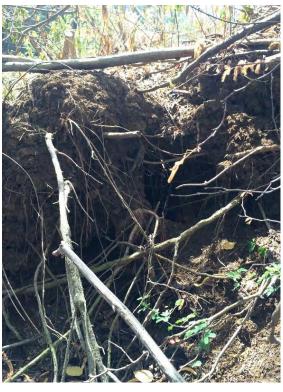
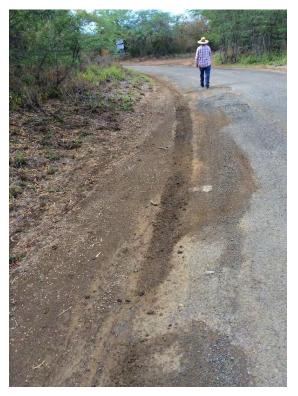
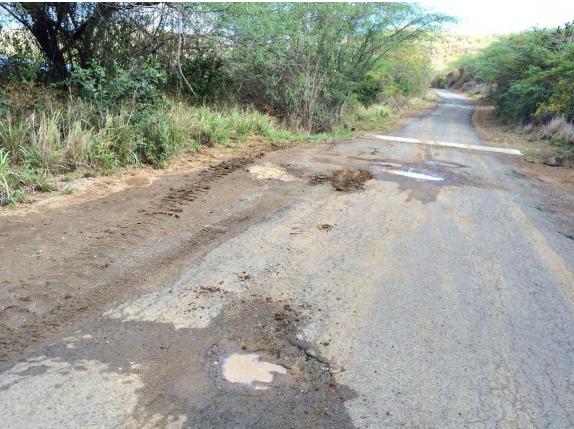
Figures 5. Pictures of existing conditions of the Tamarindo site before stabilization.

The previously paved road at the end of Tamarindo Beach has suffered a lot of changes mostly from rain, heavy traffic and lack of maintenance. This resulted with greater and newer areas of exposed soil, pot holes, and damaged drainages that were eroding the

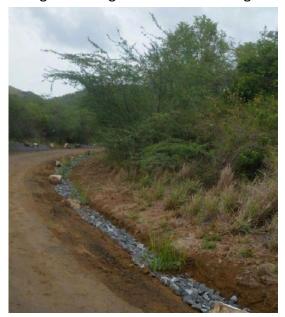
Figure 6. Stabilized culvert drainage.

sides of the road yielding sediments to the marine environment. In order to reduce runoff and dissipate its energy, we rehabilitated culvert drainages with riprap and Vetiver swales built parallel to both sides of the road. The implementation of these practices will promote sheet flow towards a series of sediment trap system built with stones after passing through

several lines of Vetiver grass with gabion stones (Figure 6). Further, water was conveyed to intercepts at 3 locations. On both sides of the road, we broke up flow paths and reduced concentrated flow over the road, thus converging flows to areas of treatment. Upon finalizing the rehabilitation, we covered most of the exposed soil with a mixture of different sizes of gravel to allow compaction (Figures 7).

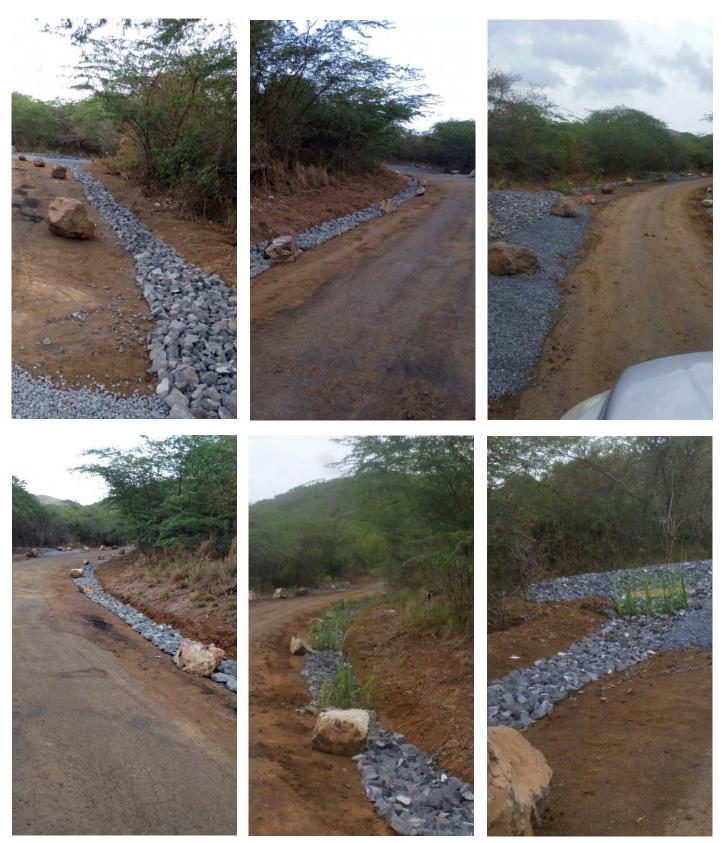
Figures 7. Pictures of some of the work completed.

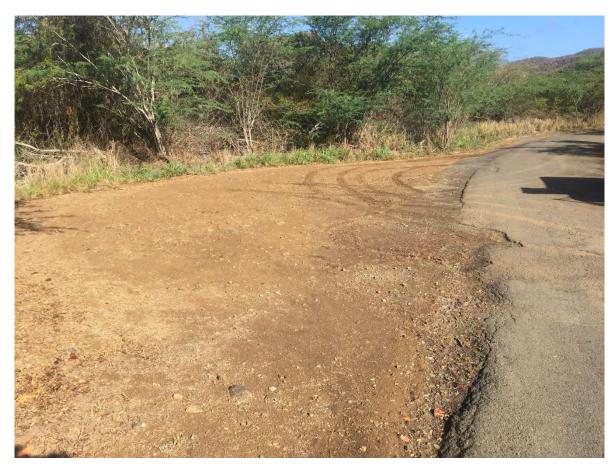
There is a huge parking demand on Tamarindo Beach and cars use most of the side of the access road to park, making it very difficult for the big passenger vans to be able to turn around. As a consequence, these large vehicles have created a dirt turnaround area over time (Figure 8). This area of exposed soils receives storm water from the uphill paved access road to Tamarindo Estates apartment complex picking up sediments on its way to the nearshore environment a few meters away, just in front of the coral farm site. Conservation practices implemented to stabilize this site were composed of a series of check dams and bio swales with the combination of excavation of 2 to 4 inches of soil and

Figure 8. Turnaround site before stabilization.

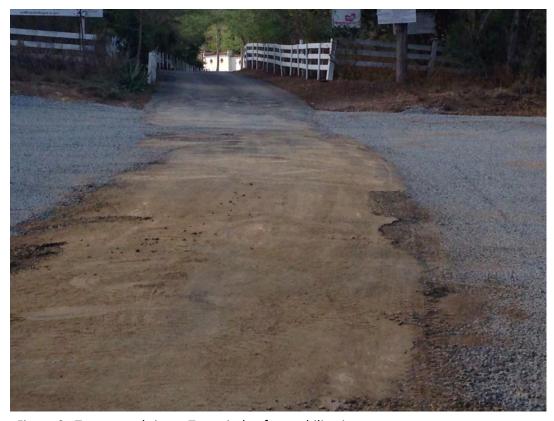
Figure 9. Turnaround site at Tamarindo after stabilization.

replacing it with a mixture of different size gravel (% - 1% inch). Gravel was also compacted with a 16 ton compacting roller (Figures 9 to 12).

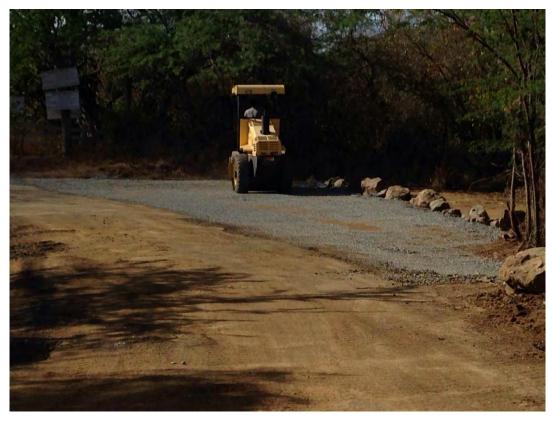
Figure 10. Turnaround site at Tamarindo during compaction process.

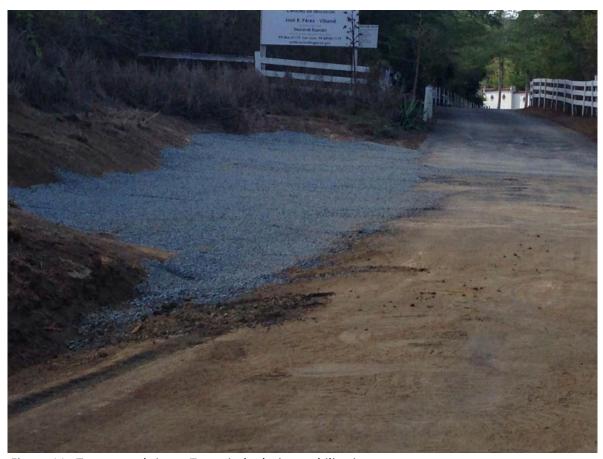
Figure 11. Turnaround site at Tamarindo during stabilization process.

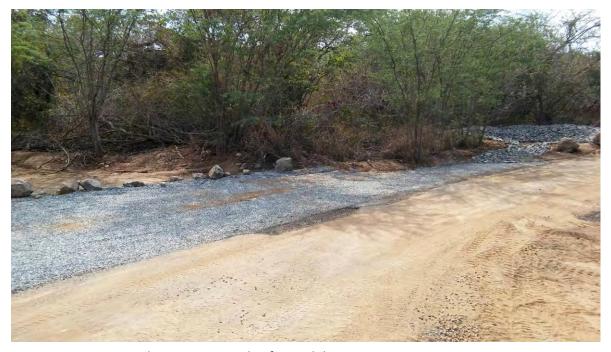
Figure 12. Turnaround site at Tamarindo after stabilization.

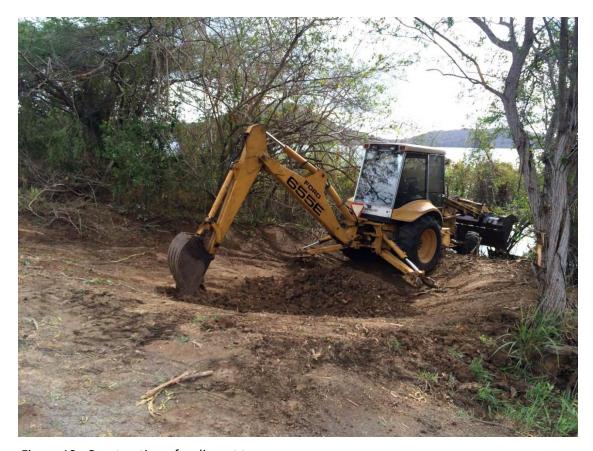
Figure 13. Construction of sediment traps process.

A sediment trap system was designed to help filter storm water that was causing erosion problems and discharging sediments to Tamarindo Beach. The entire filtration process consists of three stabilization ponds. This practice was designed to lower the erosive force of water, treat residual runoff coming from the road and divert water to forested areas. Water is conveyed to the sediment traps trough gabion stone and Vetiver grass swales. In this design the three sediment traps have a variable size to provide a reduction of sediment and hydraulic energy. This will allow water to pass throughout the system slowly while reducing sediment load. In order to ensure durability, the berms on the three sediment traps were compacted using a 10 ton vibrating compacting roller (Figures 13 to 17). Vetiver

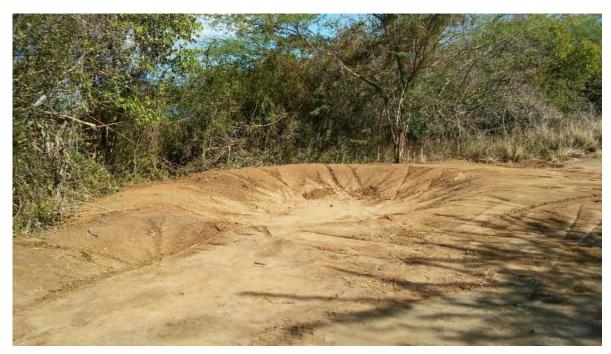
Figure 14. Sediment trap prior to be stabilized.

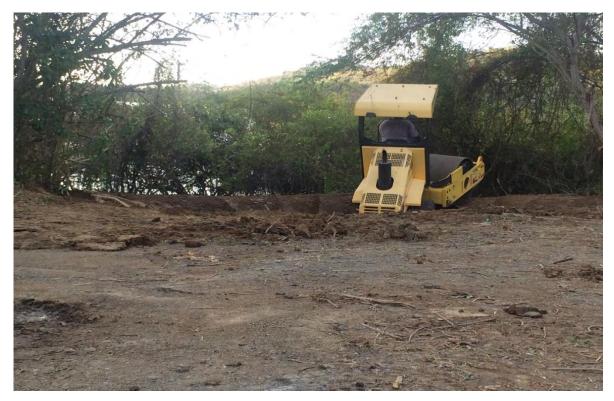
Figure 15. Sediment trap compaction of the berms process.

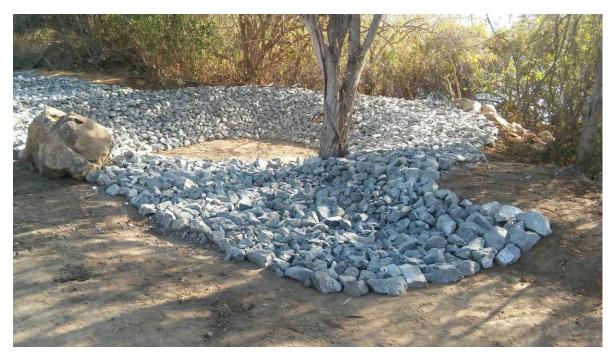
Figure 16. Sediment trap after stabilization.

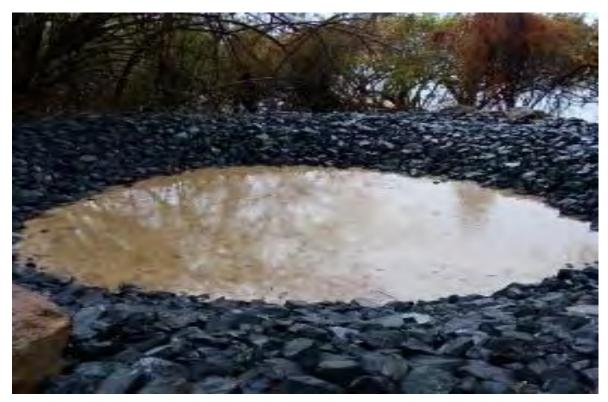
Figure 17. Sediment trap after a rain event of 2.5 inch.

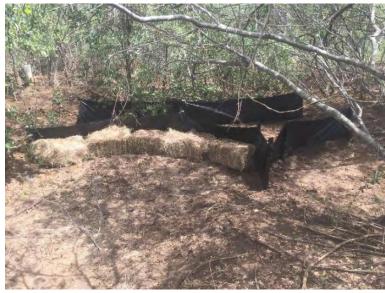
Figure 21. Example of temporary sediment control practices.

installing silt fences and planting Vetiver grass to redirect runoff to forested areas (Figure 21).

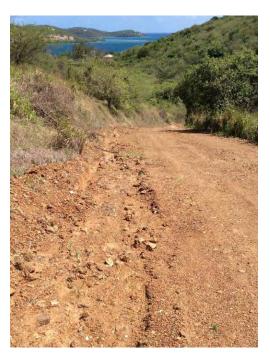
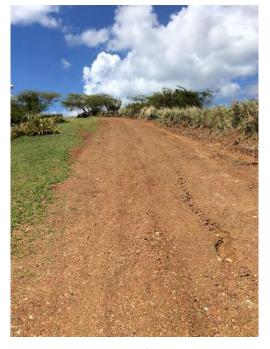
Figure 22. Pictures of existing conditions of the Fulladosa site before stabilization.

Approximately ½ mile of dirt road was stabilized to reduce sediment transport to the marine environment of Ensenada Honda. Prior to stabilization of the steep dirt road, run off was running through the center of the road causing erosion forces to drag sediments to the marine environment (Figure 22). This section of the dirt road was regraded toward the outside of the hillside and runoff was conveyed into a continuous swale with check dames at intervals of approximate 25 ft. and the road was compacted using a 20 ton compacting roller (Figure 23-28). The check dams were constructed using 8-12 inch stones to reduce the energy of the water and to hold some of the sediment resulting from the dirt road. The swale discharges runoff into a series of sediment traps and then to forested areas (Figure 29-35).

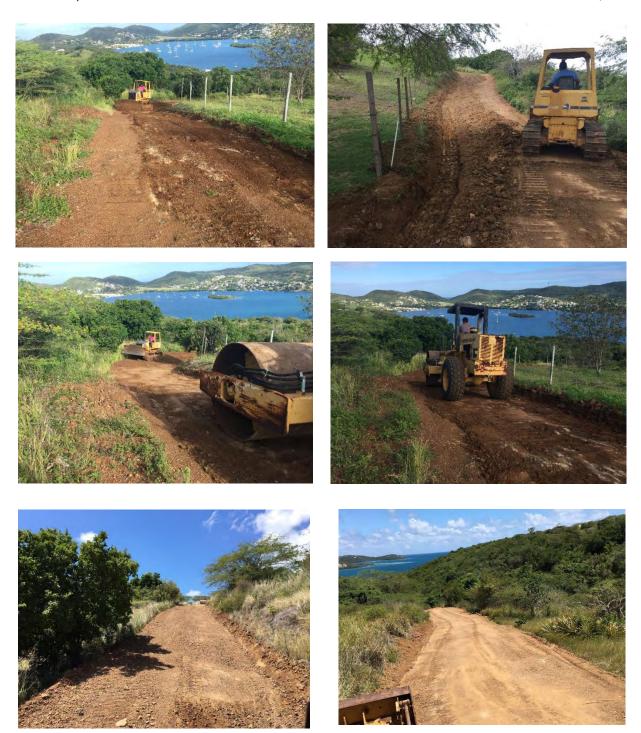
Figure 23-28. Pictures of regrading, compaction and stabilization process at the Fulladosa site.

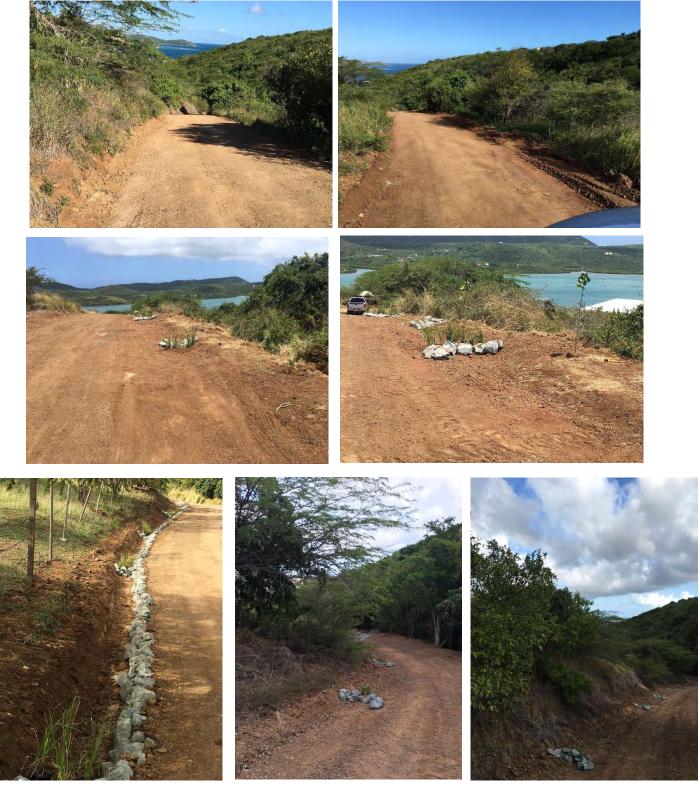
Figure 29-35. Pictures of completed dirt road stabilization with check dams in place at the Fulladosa site.

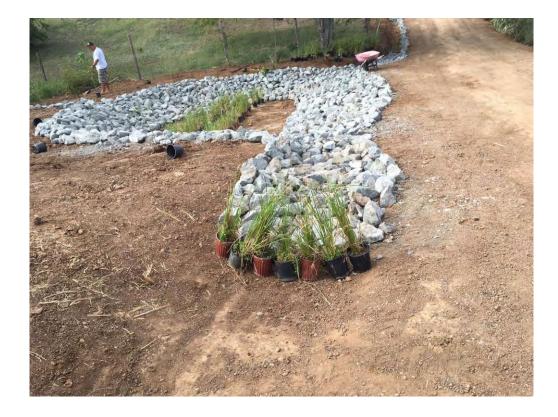
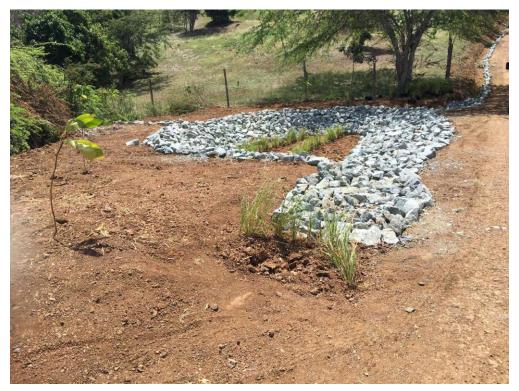
Figure 39-40. Pictures of second completed sediment trap at the Fulladosa site.

A series of 2 sediment trap systems were constructed (Figures 36-38 and 39-40). The sediment ponds were design to trap most of the core particulates and the overflow discharges through a cascade composed of combine boulders and smaller stones and various lines of Vetiver grass before entering a forested area in its way to the dry channel.

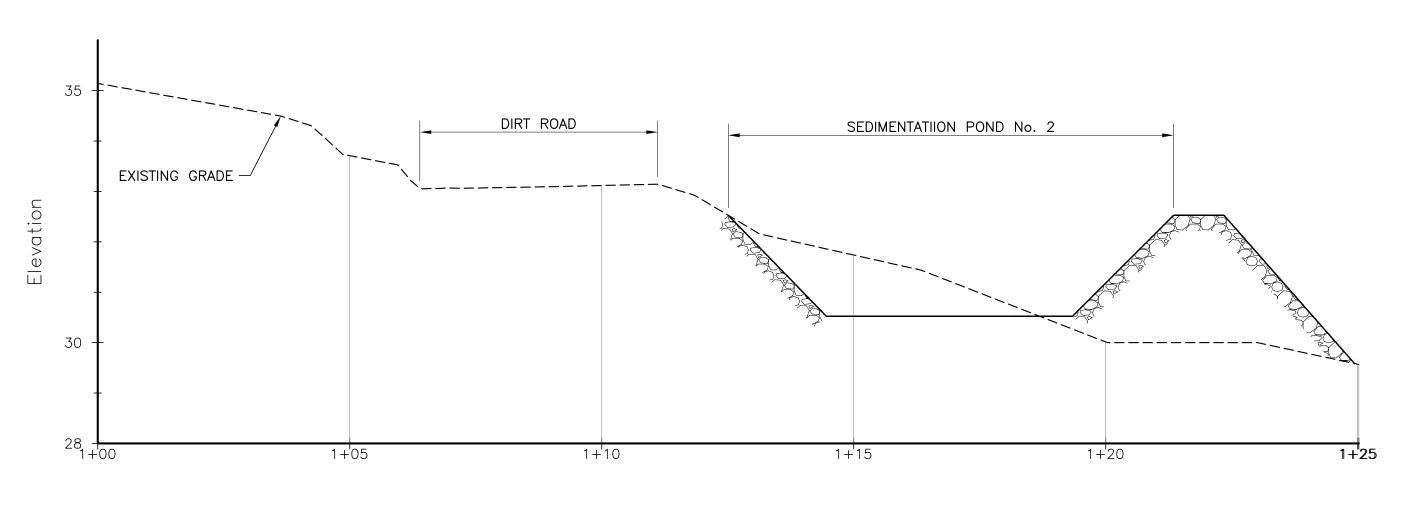
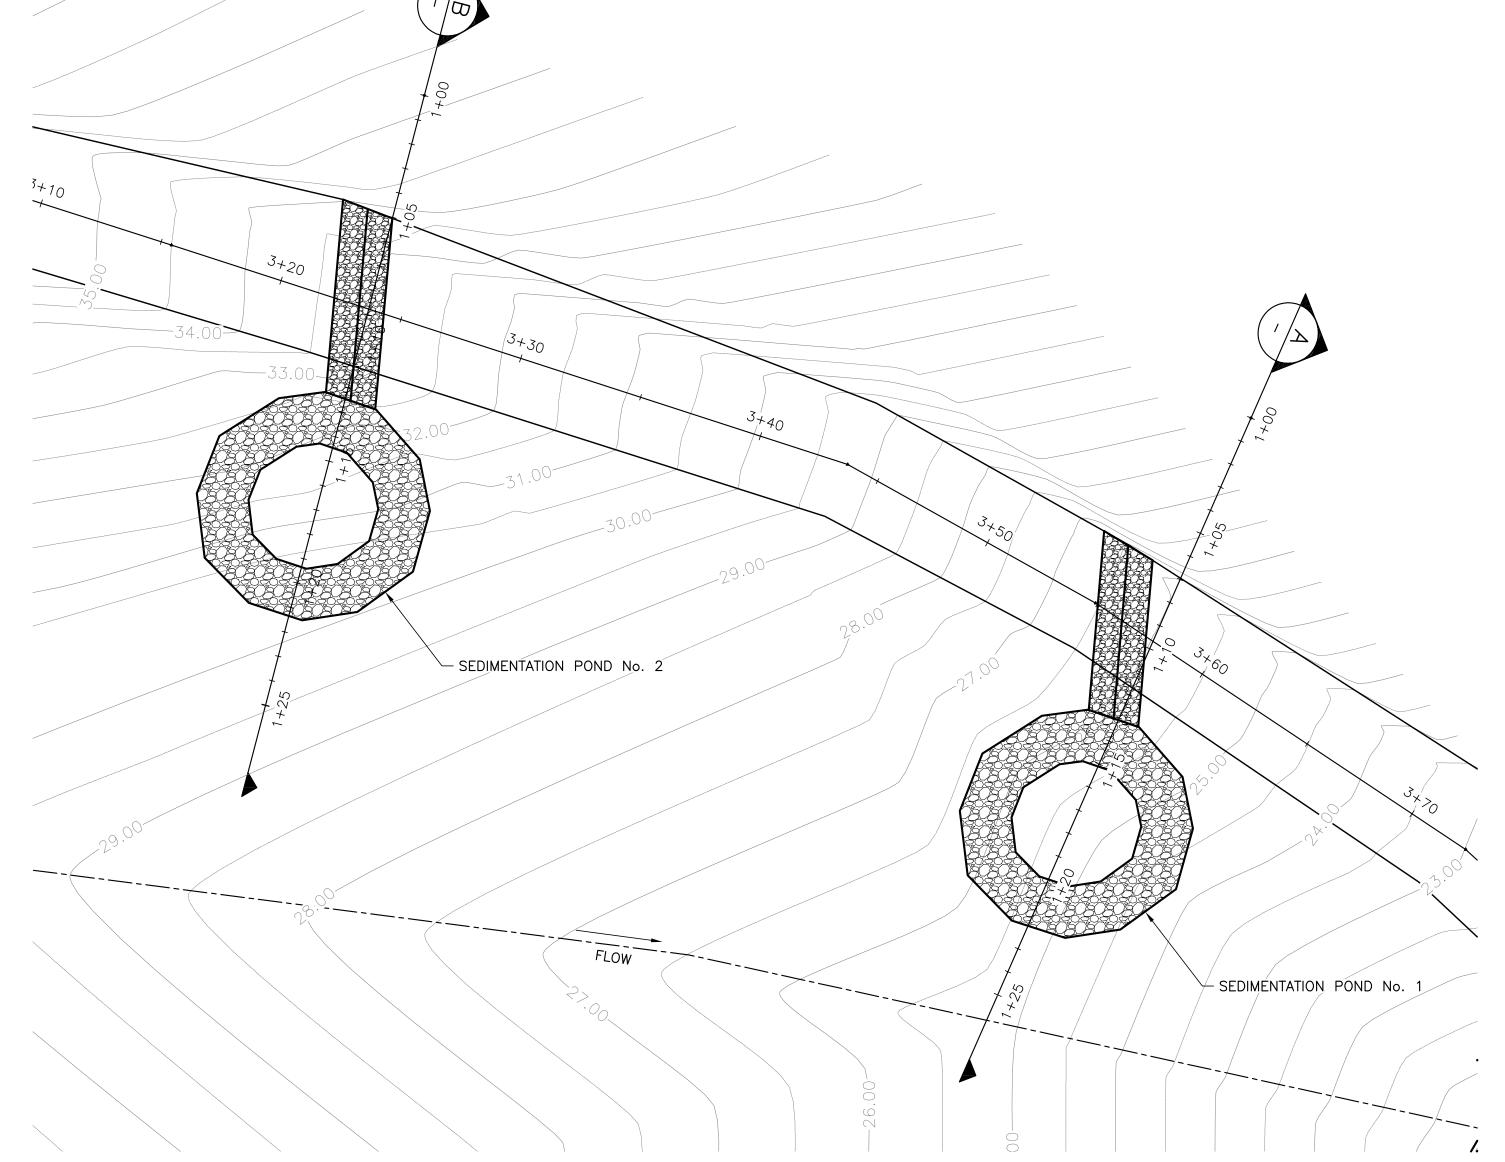
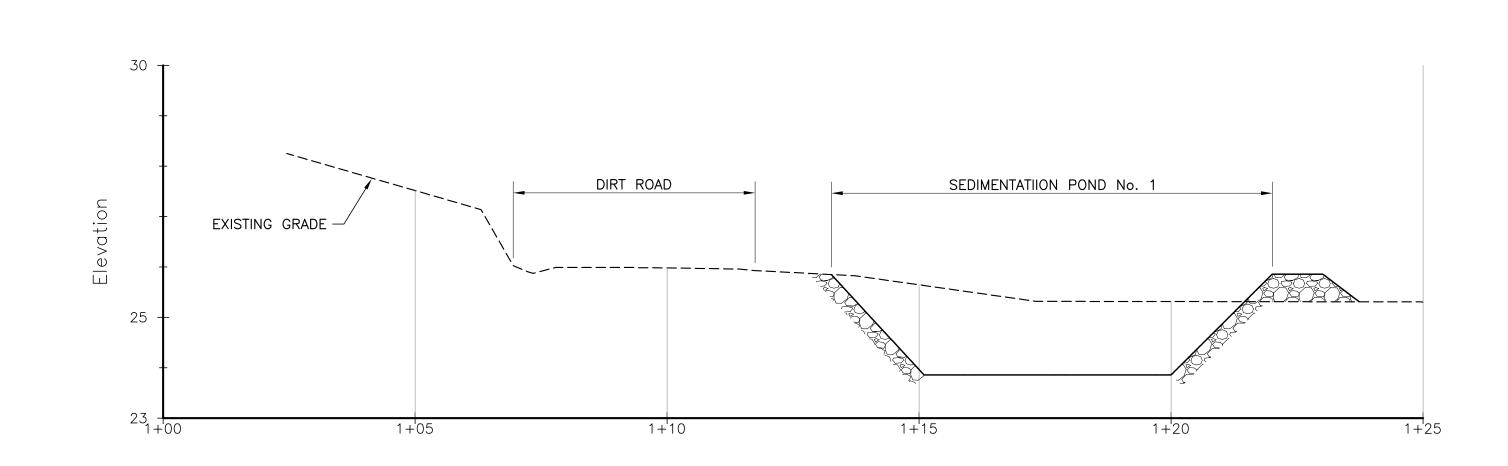
SEDIMENTATION POND NO. 1 AND NO. 2 PLAN VIEW

SEDIMENTATION POND No. 2 SECTION VIEW SCALE: 1=75
